FACTORS CAUSING STRUCTURAL FAILURE OF THE FLEXIBLE PAVEMENT ALONG TIMBOROA TO MALABA ROAD IN KENYA

Key words: Transportation, Flexible Pavement, Distresses, Rutting

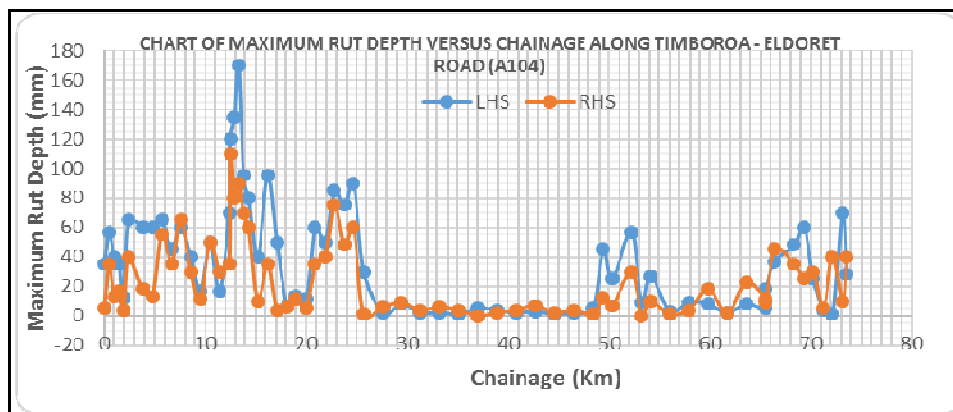
Figure 1 Maximum rut depths along Timboroa – Eldoret Road (A104)

The Figure 1 illustrate the maximum rut depth from chainage 0 to chainage 80. It was observed that 36% of the road is in a sound condition, 15% of the road will need minor overlay for more than 20% of the road length and 49% of the road will require reconstruction.

Permanent deformation in asphalt (flexible) pavements, commonly referred to rutting, usually consists of longitudinal depressions in the wheel paths, which are an accumulation of small amounts of unrecoverable deformation caused by each load application. From the rut depth measurements it is evident that rutting was more severe on the Left Hand Side (LHS) as compared to the Right Hand Side (RHS) of the road. This

can be attributed to overloading of the heavy goods vehicles travelling from the port of Mombasa to the border town of Malaba. The South bound heavy goods vehicles from Malaba towards Timboroa are usually empty having delivered their cargo to their destination therefore explaining the less austere rutting on the RHS. Results from the Atterberg limit tests indicate a subgrade composed of clay of medium to high plasticity. This type of clay is the most possible cause of the heavy rutting in some sections of the highway due to permanent deformation emanating from traffic loading.

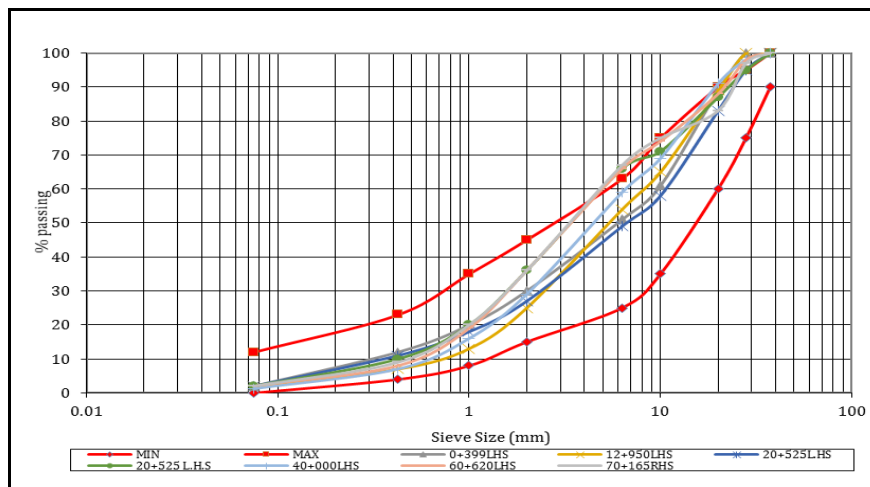
Figure 2 Grading curves for subgrade soil along Timboroa – Eldoret Road

Soil samples for the subgrade layer were also subjected to sieve analysis. The results from the sieve analysis are shown in Figure 2. The plotted grading curves indicate that they fall within the envelope of the maximum and minimum recommended sizes. This shows that the subgrade soil was well graded in most sections along the Timboroa - Eldoret road. The subgrade soils along the road section ranged between fine silts to coarse gravel.

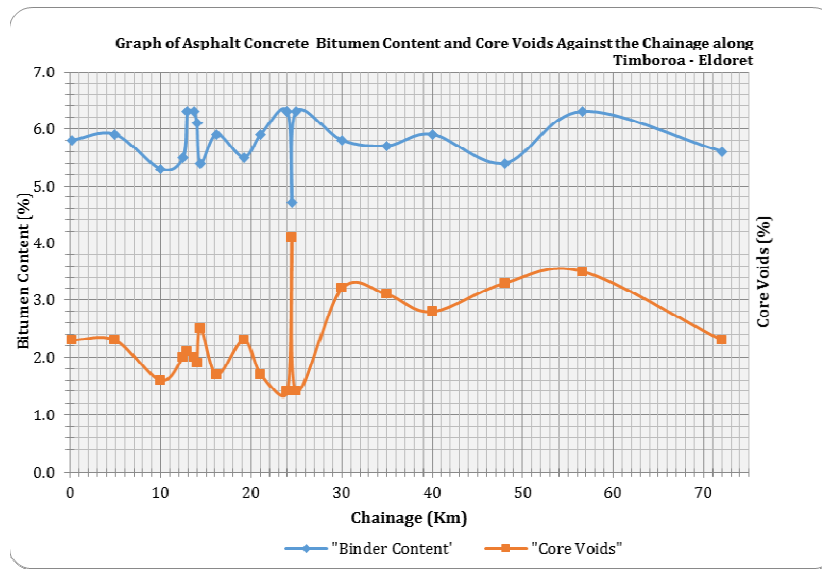
Figure 3 Bitumen content and Core voids for Asphalt Concrete

From Figure 3, the binder content for the Asphalt Concrete cores ranged from 4.7% to 6.3% with an average of 5.8%. The core voids ranged from 1.4% to 4.1% with an average of 2.4%. The voids in 75% of the cores tested are below the specified minimum (3%) for Type I wearing course for this road section (according to Kenya Road Design Manual - KRDM Part IV 1987).

From the core samples the core voids for both the asphalt content and the dense bitumen macadam was far below the minimum required as per the standard design specifications in Kenya. The grading curves plotted for the core aggregate samples for the AC and DBM indicate that the materials used during the construction stage for AC and DBM layers were poorly graded for most parts of the road section.

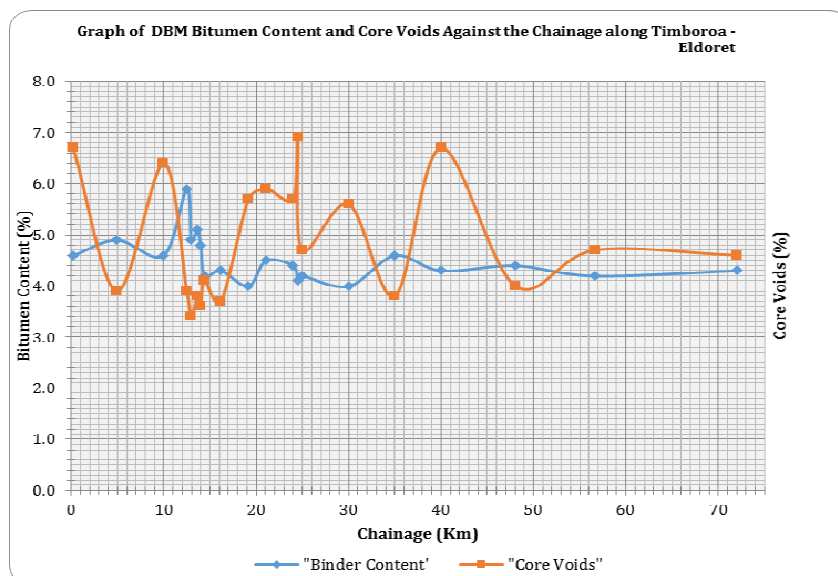
Figure 4 Bitumen content and Core voids for DBM

The binder content from the DBM cores as shown in Figure 4 ranged from 4.0% to 5.9% with an average of 4.5%. The core voids ranged from 3.4% to 6.9% with an average of 4.9%. The core voids in 35% of the cores tested are below the specified minimum (4%) for DBM in the standard specifications (KRDM Part IV 1987).

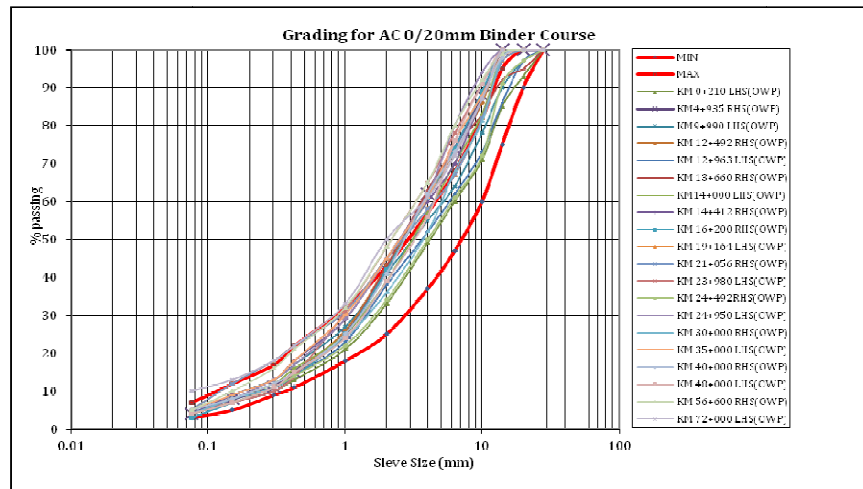
Figure 5 Grading curves of AC core aggregates

The grading curves taken for the AC core aggregates and the DBM core aggregates indicates that both the asphalt concrete and dense bitumen macadam aggregates are outside their respective recommended envelopes or specifications. Previous research studies have realized the important role, the coarse aggregate plays in the rutting behavior of HMA related aggregate structure stability to coarse aggregate morphologies (Klaus, 2003). Conversely, instead of locking together, smooth, rounded aggregate particles tend to slide past each other. If the aggregate provides a high degree of internal friction (ϕ), the shear strength of the asphalt mixture will be increased and, therefore, the resistance to rutting. This is accomplished by selecting an aggregate that is angular, cubical, has a rough surface texture, and is graded in a manner to develop particle to particle contact (McGennis *et al*, 1994)
