# Structural Characterisation of the Failed Manafwa Historic Bridge in Uganda

Dan Iga<sup>1</sup>, Dr. (Eng.) Timothy Nyomboi<sup>2</sup>, (Eng.) Richard Ocharo Onchiri<sup>3</sup>

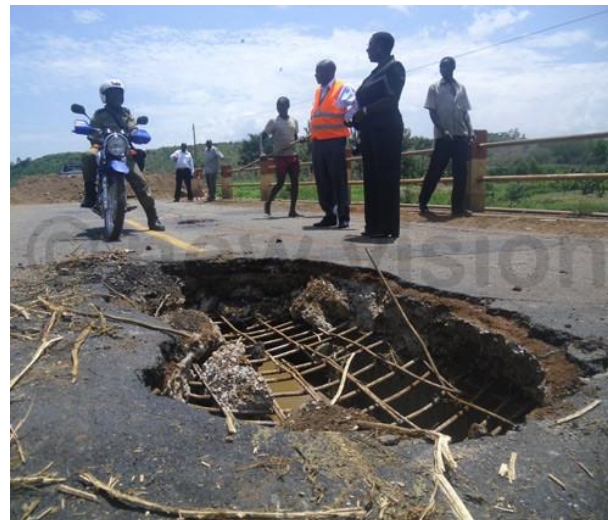
Figure 1: Cracks in the Manafa bridge (The slab may not have been connected to the steel girder using studs)

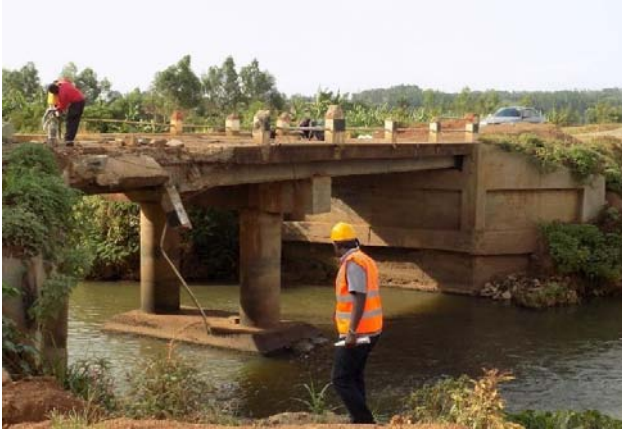
### 2.1.2 Bridge Superstructure Slab

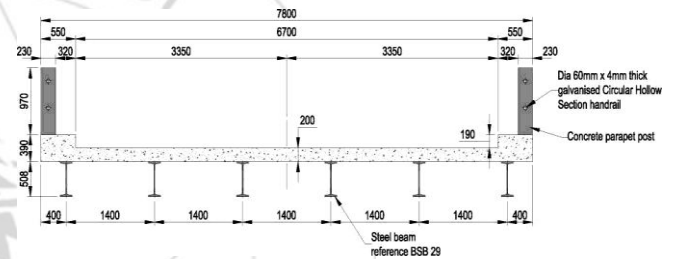
**Figure 4:** Manafwa River Bridge superstructure cross section

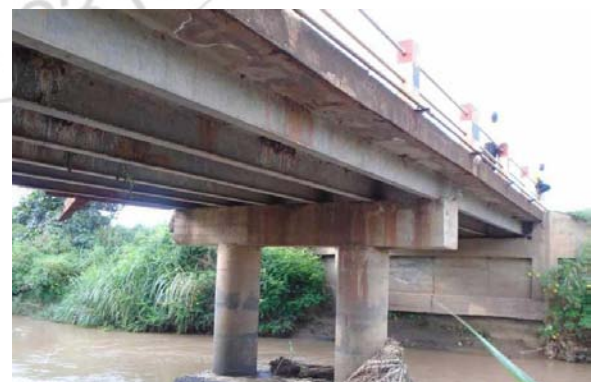
**Figure 5:** Bridge underside showing steel beams and pier.

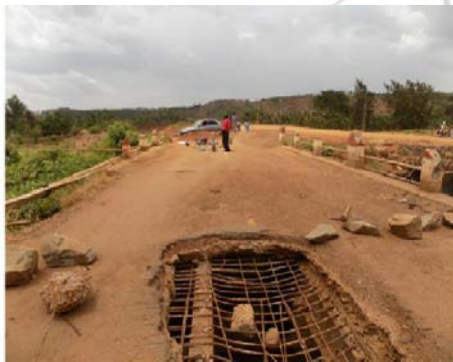
Figure 7: Manafwa River Bridge superstructure cross section immediately after the failure and before the visual inspection on the bridge (L-R).

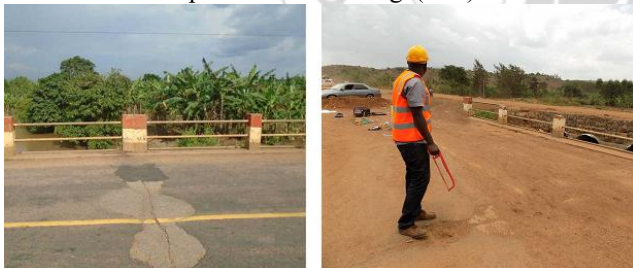
Figure 8: Transverse crack in deck surfacing and concrete patching. There is no transverse joint in the concrete slab on the underside

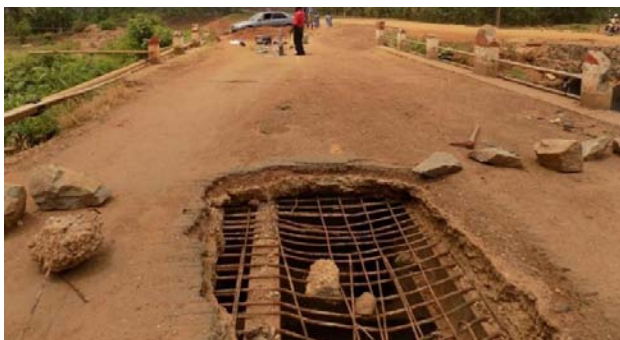
Figure 9: Opening in superstructure slab. Maximum length of opening parallel to traffic flow direction is 2530mm and it is 1350mm in the normal direction

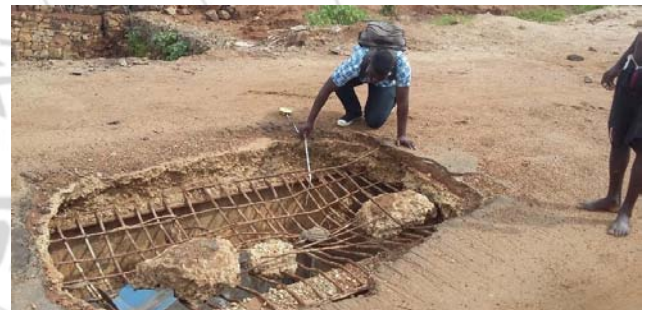
Figure 12: Bottom reinforcement at failed slab location. The reinforcement is diameter 16mm round bars at 100mm centres

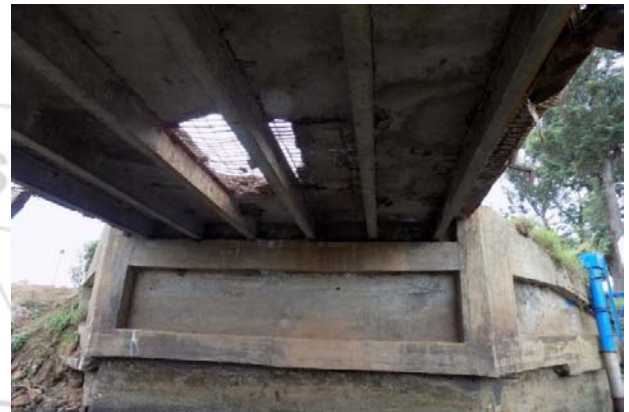
**Figure 14:** Falling off of the plastered underside of the superstructure slab aimed at concealing the exposed reinforcement bars

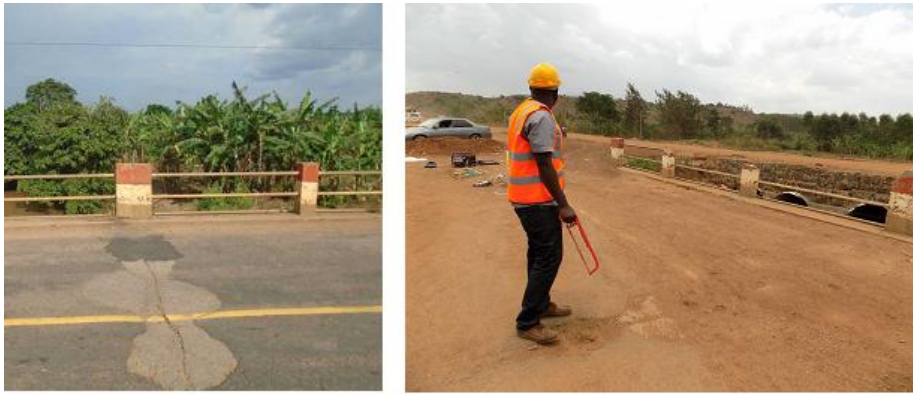
Figure 15: Transverse crack in the slab running to the bottom of the layer
