# Effects Associated with Processing Ballast and Waste Oil at Port Reitz, Mombasa-Kenya

## Abstract

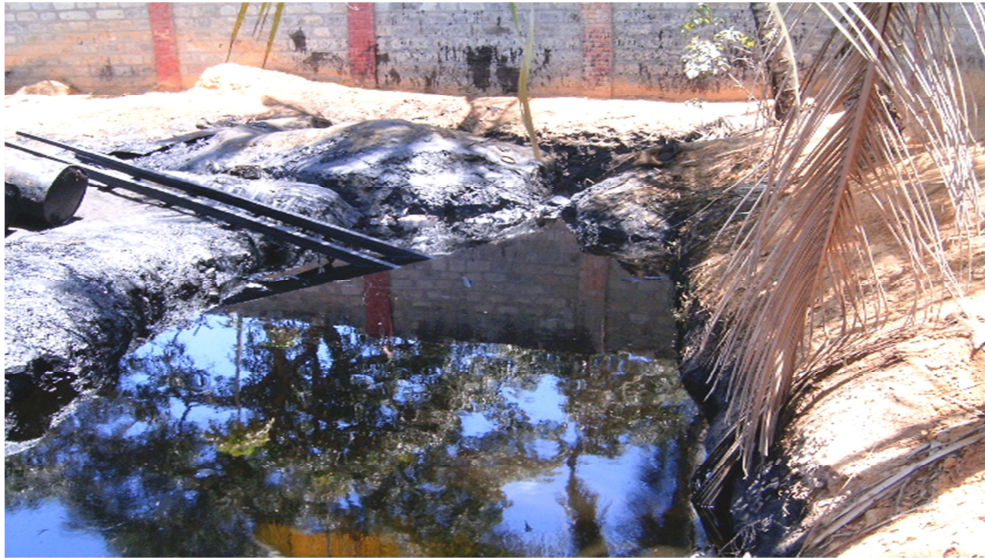
The processing infrastructure comprised of a system of two earthen ponds, a shallow pond measuring 5 meters X 3 meters X 2meters depth and second adjoining pond of size 4 meters X 3 meters X 2.5 meters depth. These were used to contain the residual oil water remaining from the separation process that remained in the tanker after the intended product had been drained into storage tanks. The oily water was allowed to settle further in the shallow pond and periodically the surface was skimmed for oil. The retrieved oil stored in 200 litres' steel drums before transfer into larger storage tanks. The wastewater with oil residues that could not be recovered was then allowed to flow into the second deeper pond for storage. Occasionally, the wastewater was sold to other manufacturing industries to use in their processes such as utilization in the brick making process. The system of ponds for holding and processing the wastewater is shown in Figures 1 & 2. To support these operations, the operator had 4 tankers of 25 tons capacity each, 2 Canter Lorries of 3 tons capacity each, 1 lorry fitted with a pump, and storage tanks for the product with a capacity 100 tons. There was a strong odour pervading the facility and premises. This was primarily due to the poor handling and processing methods, which resulted in leakages and wastage. The leakages and spillages occurred during the pumping operations and, from the storage tanks. Also, the manual skimming of oil from the earthen separation ponds, and transfer to the storage drums cause further spillages, contaminating the soils with the fuel oil.

Fig. 1: The shallow wastewater receiving and holding pond. Note the dark fuel oil skimmed from the pond

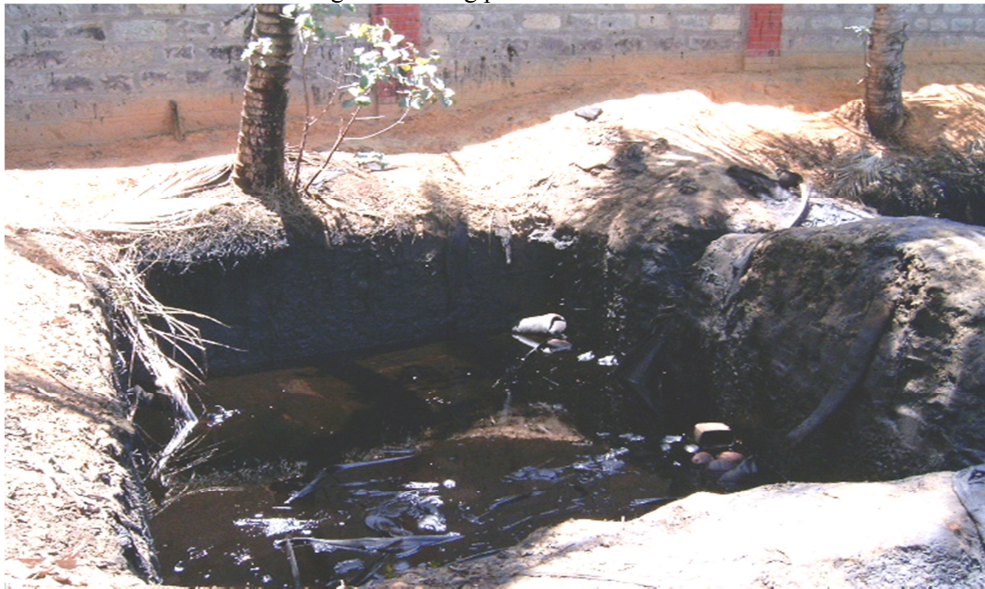
Fig. 2: The second deeper wastewater storage pond

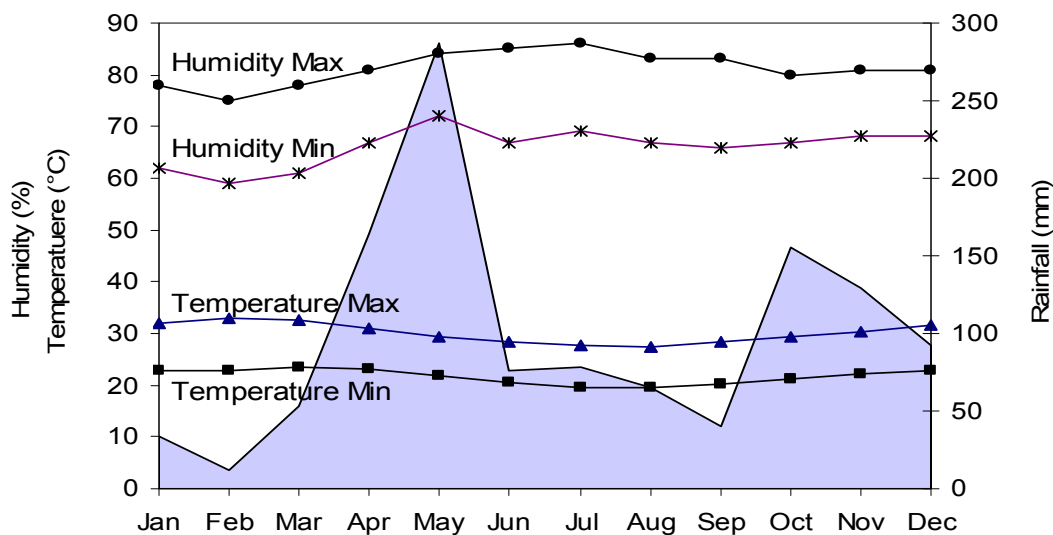
Rainfall is diurnal with the long rains occurring in the inter-monsoonal period, starting towards the end of March and peaking in May. Over 60 % of the rainfall occurs during the long rains. High cloud cover (relatively low radiation ranging from 17.1 – 20.5 MJ m<sup>-2</sup>) and relatively higher humidity conditions (mean relative humidity range 61 – 86 %) are experienced during this season; and low temperatures, prevail in June/July due to the cool winds blowing from the south. There is a diurnal variation in the relative humidity, particularly in Mombasa where humidity attains about the 60 – 70 % range during the afternoon, rising to 92 – 94 % during the night and early morning (UNEP, 1998). Short rains occur in the next transition period between October and November. The Mombasa District on average receives a mean rainfall of 1027 mm yr<sup>-1</sup>. Fig. 3 presents the rainfall distribution, temperature and humidity variations in the Mombasa.

Fig. 3: Temperature, relative humidity and rainfall averages for Mombasa for 1989 – 1999.  
 (Source: Kenya Meteorological Department, Moi International Airport, Mombasa)

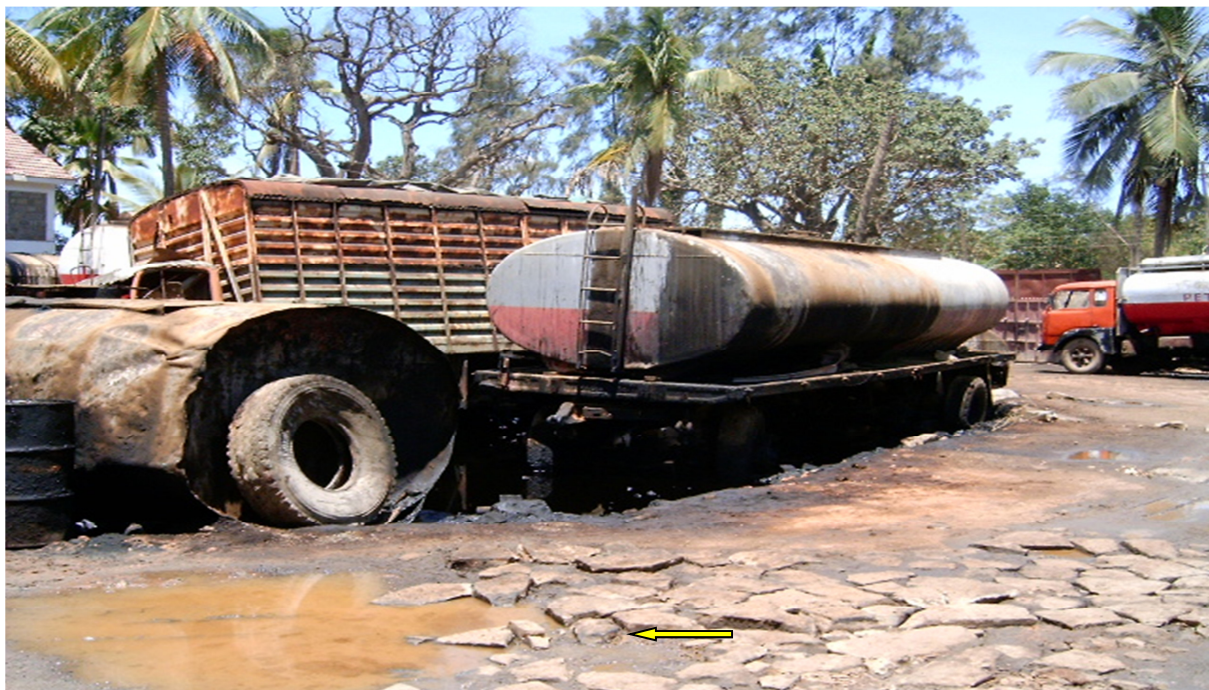
The most visible impact of the ballast water and oil sludge handling and processing activities at the facility is the extensive contamination of the soil with heavy fuel oil, resulting from leaks and spills during processing/storage operations. In the absence of proper waste oil handling facility on the site, oily waste had spread within the compound. In the middle of the plot, a 25 ton capacity storage tank had leaked, resulting in a thick layer of black oil (Fig. 5). It was estimated that between 60 and 70 % of the area within the plot not occupied by the office building was covered with oil, contaminating the soil and vegetation. The magnitude and persistence of the oil on the ground was demonstrated by the pools of oily water. Though large patches of areas had been covered with fresh soil to hide evidence oil spillage, its presence was still evident. The immediate impact of oil pollution on the soil surface was the loss of aesthetic beauty of site with the unpleasant looking patches of oil, reducing the amenity value of the property. Chronic oil pollution effects on the soil were manifested by the lack of vegetation including, impact to perennial plants and trees. Grass was non-existent, and mango and several coconut trees had defoliated and withered.

Fig. 5: One of the oil storage tanks at the premises. Note the pool of leaked-out oil with water below the storage tank (arrowed), and the results of attempts at rehabilitating oiled sections by spreading stones and murrum.

There were no contingent measures to combat accidental oil spills. This was aptly evident from the lack of band-walls around the oily-water holding pits. Attempts to rehabilitate the worst affected areas by filling the pools and potholes with stones and spreading fresh soil or murrum (see Fig. 5), had been undertaken, however the initiative had not been effective, for, except for hiding the unsightly areas, the effort tended to have aggravated the situation in some important aspects by creating conditions that favour long-term persistence of the contaminant in the soil, rather than promoting natural degradation when exposed to the air environment. This resulted in the preservation of the oil under the soils, with the consequences that the soil could not support plant growth. Similarly, this aggravated the potential for groundwater contamination through aquifer recharge during the rainy period.

It is recommended that the operator obtains the necessary legislative authority governing this type of activity. Proper drainage systems, as required by the Public Health Act, 1972 should be provided while the oil storage tanks should be secured with a band wall to hold and retaining oil in the event spillage occurs, as dictated by the Energy Act, 2006; conditions that promote natural degradation of oil sludge and contaminated soil and/or even using microbial organisms should be put in place. The workers should be provided with appropriate personal

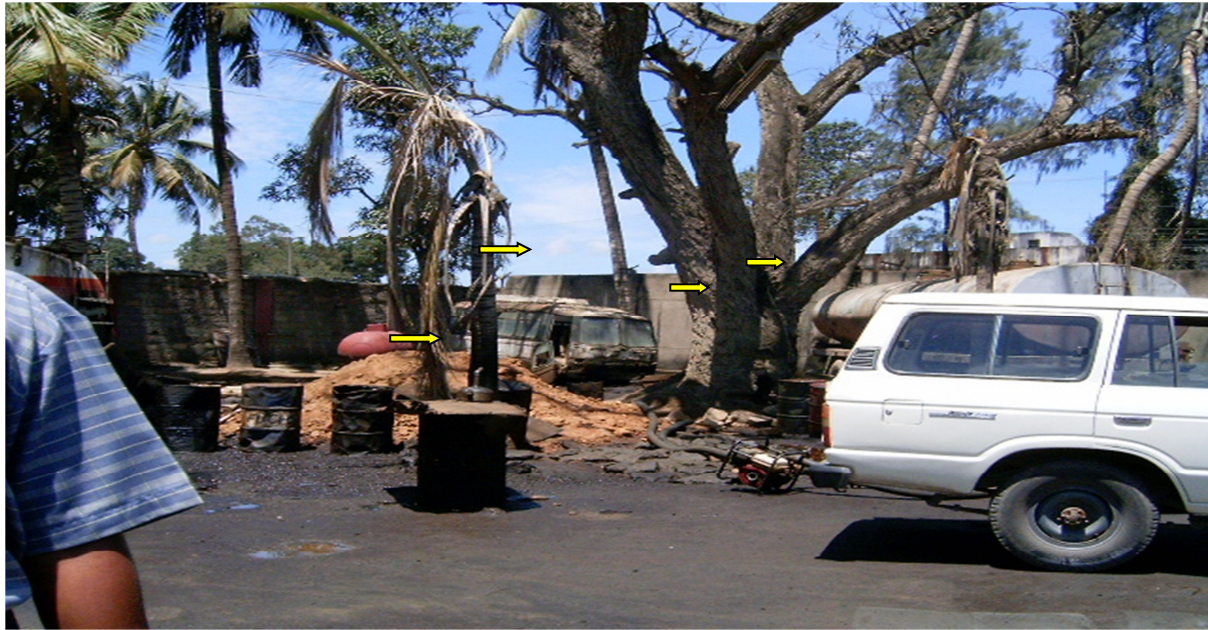
Some of the critically affected trees are clearly evident in Fig. 6. Most of the open areas of the plot were virtually barren and it was just a matter of time before all the remaining vegetation became completely destroyed. The observed impact of oil pollution to vegetation at the site was a clear indication of acute toxicity effects. The toxic components of fuel oil include Polycyclic Aromatic Hydrocarbons (PAHs), some of which are known environmental carcinogens, an issue not investigated in this study.

Fig.6: Impact of chronic oil pollution of the soil - withered mango and coconut trees (arrowed). Note the oil contaminated foreground and mound of fresh soil for covering the oil pools in the background.

Presented in Table 2 are the estimates of the cost of rehabilitation of the contaminated compound. In computing the estimates it was considered that for the coconut and mango trees to be affected, the oil should have penetrated to a depth of at least 1 m. Thus, the estimates were made with the assumption that a layer of soil 1 m thick will be excavated from the site and transported about 25 km to the municipal dumpsite located at Mwakirunge for disposal, and fresh uncontaminated soil, obtained from Utange about 20 km away, would have to be transported to the premise to replace that which had been excavated. Labour costs associated with the excavation and loading the soils to and away from the premise, including spreading of the fresh soil were considered.
