Rutting Failure on Pavement Layers along Timboroa to Eldoret Road Section in Kenya

ABSTRACT

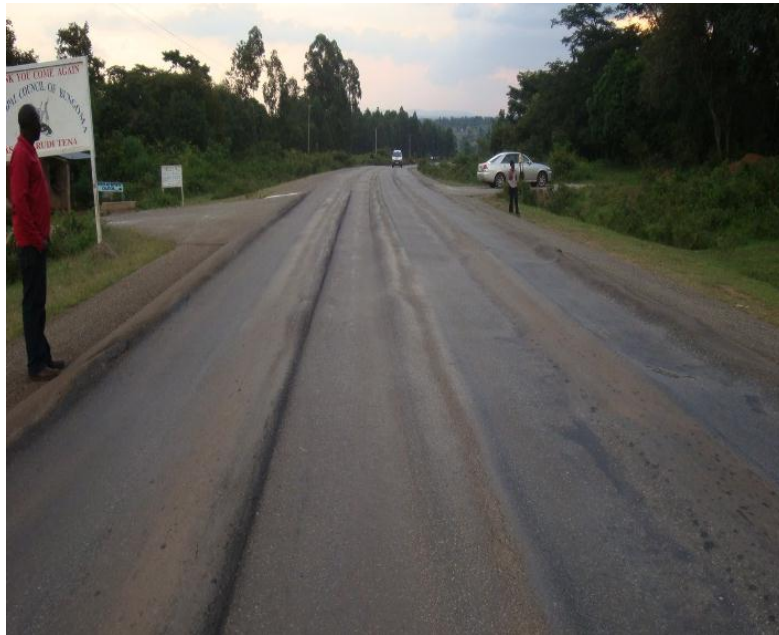
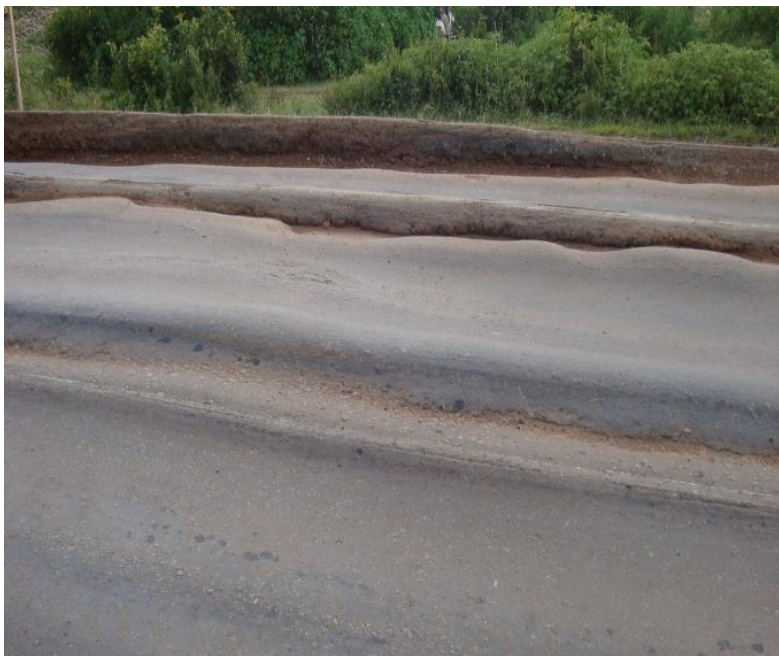
The stability of the pavement layers and more so the subgrade layer relies immensely on the drainage conditions of an area (Salama 2005). A poorly drained soil will cause the water table to raise and therefore affect the subgrade layer which is the foundation. It is observed that rutting was prevalent in the well-drained sections as well as those that are moderately well drained. This means that the drainage condition did not play a significant role on the development of rutting on the road section. Apart from a few swampy areas observed around Timboroa and toward Eldoret town, it is imperative that the ground water table was apparently deep and therefore not significantly affecting the road pavement. The rutting failure as shown in Plate 1 was so severe in some sections not necessarily with drainage problems but dictated by other factors (Waweru et.al 2016).

Plate 1: Severe rutting observed along the road section

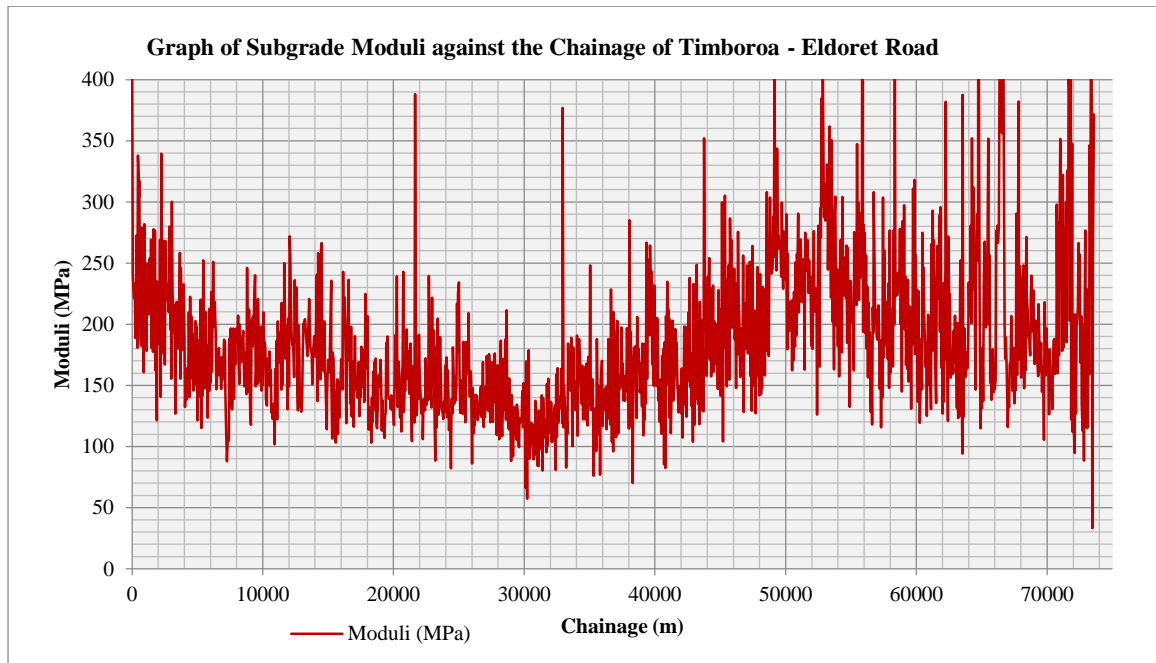
Figure 2: Moduli of subgrade layer along Timboroa – Eldoret section

From the plots in Figures 2 to 5, the following can be deduced after the analysis of moduli of elasticity values for the different layers at a pavement temperature of 25⁰C which is equivalent to air temperature of 20⁰C given in Kenya Road Design Manual part IV:

- (i) **Sub-grade:** The average elastic moduli values indicate sub-grade Classes S5 at in-situ moisture condition;
- (ii) **Sub-base:** The average elastic moduli values for most sections are above the moduli values attributed to neat GCS of 400 MPa therefore the sub-base layer is considered to be stable due to consolidation;
- (iii) **Base:** The average elastic moduli values are above the value of 5000 MPa attributed to dense bitumen macadam.
- (iv) **Surfacing:** The average elastic moduli values are above the value of 4000 MPa attributed to Asphalt Concrete.

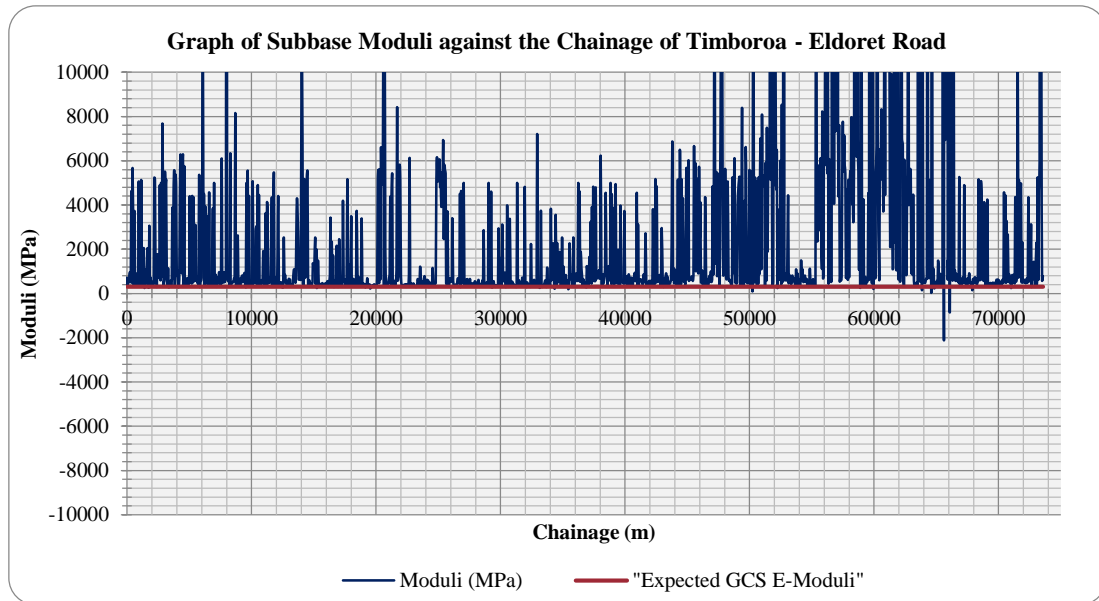
Figure 3: Moduli of subbase layer along Timboroa – Eldoret section

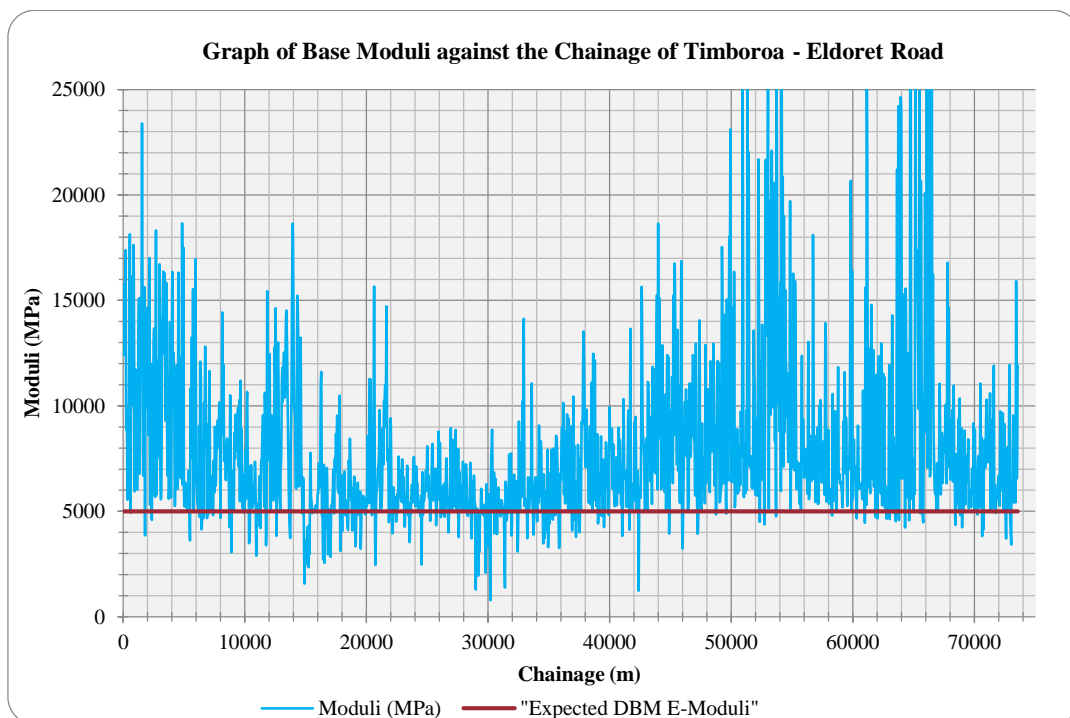
Figure 4: Moduli of base layer along Timboroa – Eldoret section

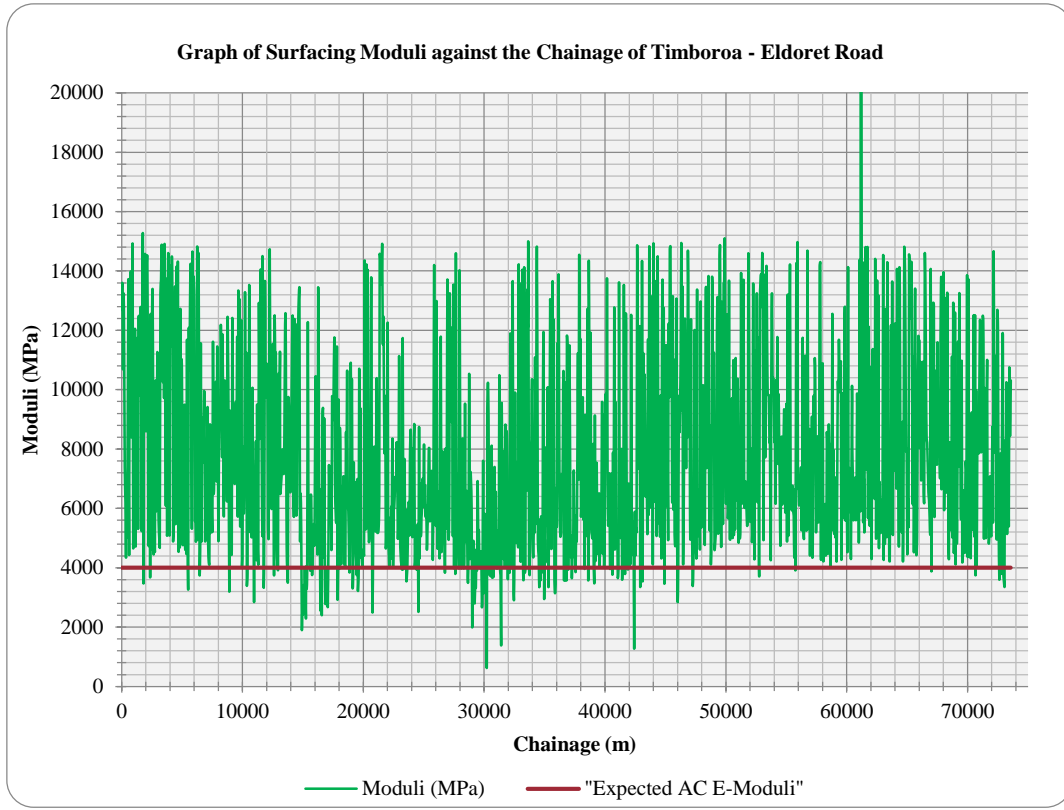
Figure 5: Moduli of Surfacing along Timboroa – Eldoret

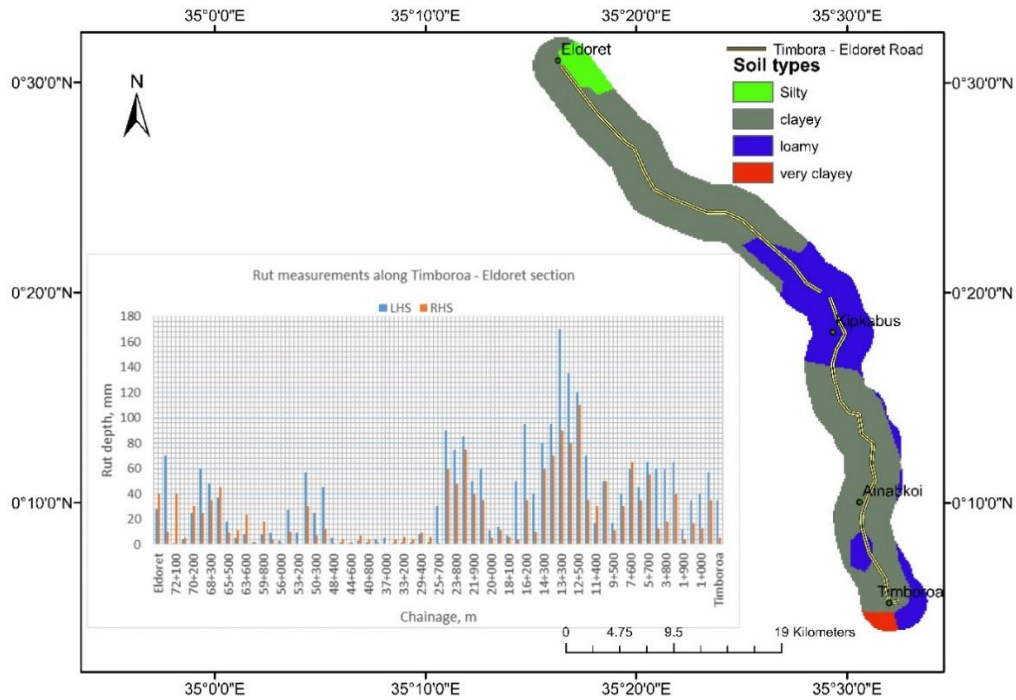
In this study the soil texture was used to compare the rutting distress to the soil profile type along the Timboroa to Eldoret road section. From Figure 6 it is observed that severe rutting was taking place in the road sections with clayey soils as the subgrade material.

Figure 6: Correlation between Rut depth and the Soil type

Most sections of the road were dominated by the red clay soil and in some instances the expansive clay soil locally referred to as black cotton soil. In sections covered by the loamy soils less rutting was experienced. From these analysis it can established that the subgrade layer is the major contributor to the stability of the pavement against the rutting problem.

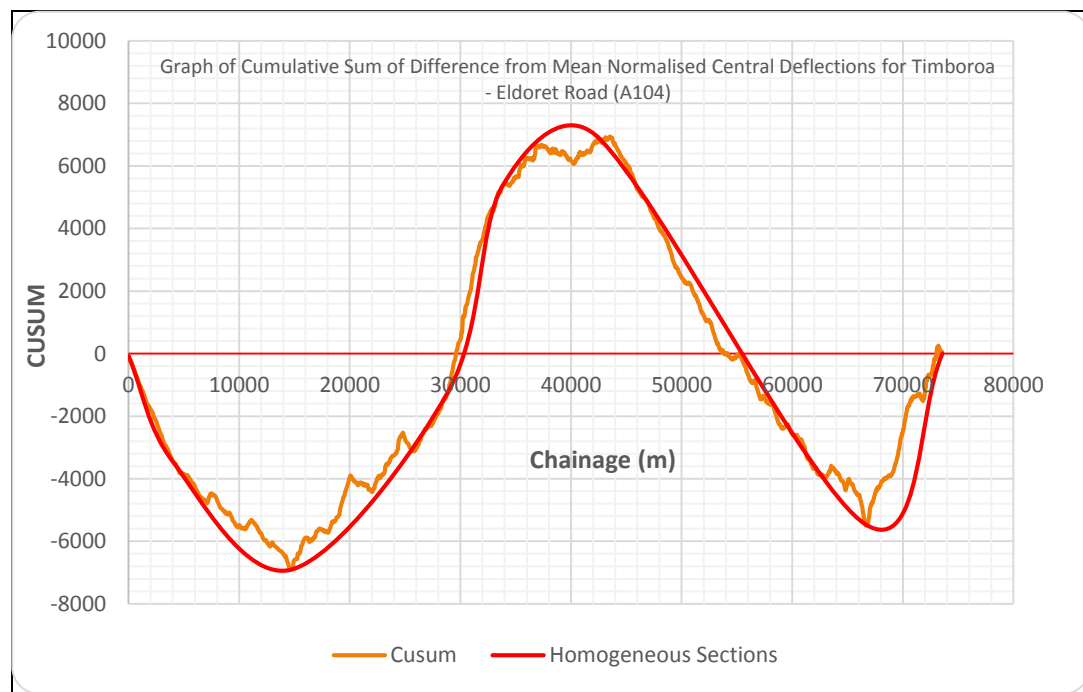
Identification of homogeneous sections was achieved using cumulative difference method of the central deflections (Myers et.al 1999). Results for the cumulative sum of mean normalised central deflections for the homogeneous sections are plotted in Figure 9. The results indicate that the mean normalized central deflection was very high in the first stretch of the Timboroa to Eldoret road section from chainage 0 to 30 Km and chainage 55 to 73 Km indicating a serious problem with the pavement layers.

Figure 9: Plot of Cumulative Sum of Mean Normalized Central Deflections

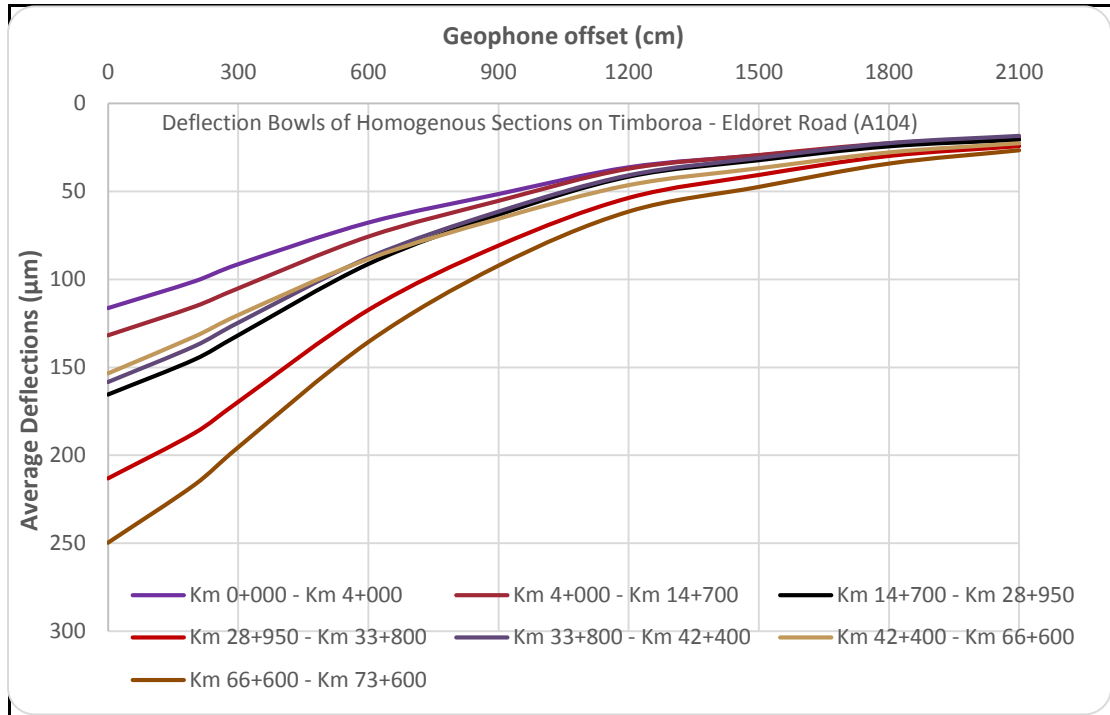
The strength of the sub-grade and variation of strength in pavement layers affect the shape and form of the deflection bowl. The deflection bowls for the selected homogenous sections are as shown in Figure 10.

Figure 10: Deflection bowls of Homogenous sections

From the plots of the deflection bowls represented in Figure 10 for the Timboroa to Eldoret road section, the following can be deduced:

- (i) The sections from Km 0+000 – Km 4+000 and Km 4+000 – Km 14+700 have stronger pavements compared to the other sections as indicated by the shallow deflection bowl; and,
- (ii) The section from Km 66+600 – Km 73+600 has the weakest pavement as shown by the deep deflection bowl.
